New Hampshire Volunteer Lake Assessment Program

2002 Interim Report for White Oak Pond Holderness

NHDES
Water Division
Watershed Management Bureau
6 Hazen Drive
Concord, NH 03301

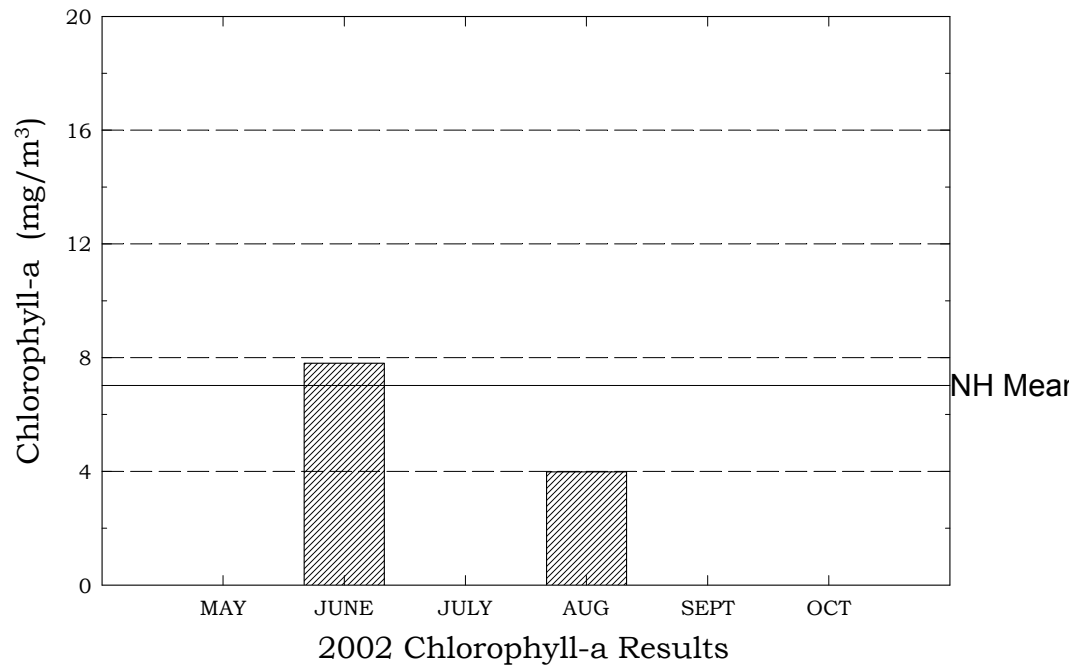
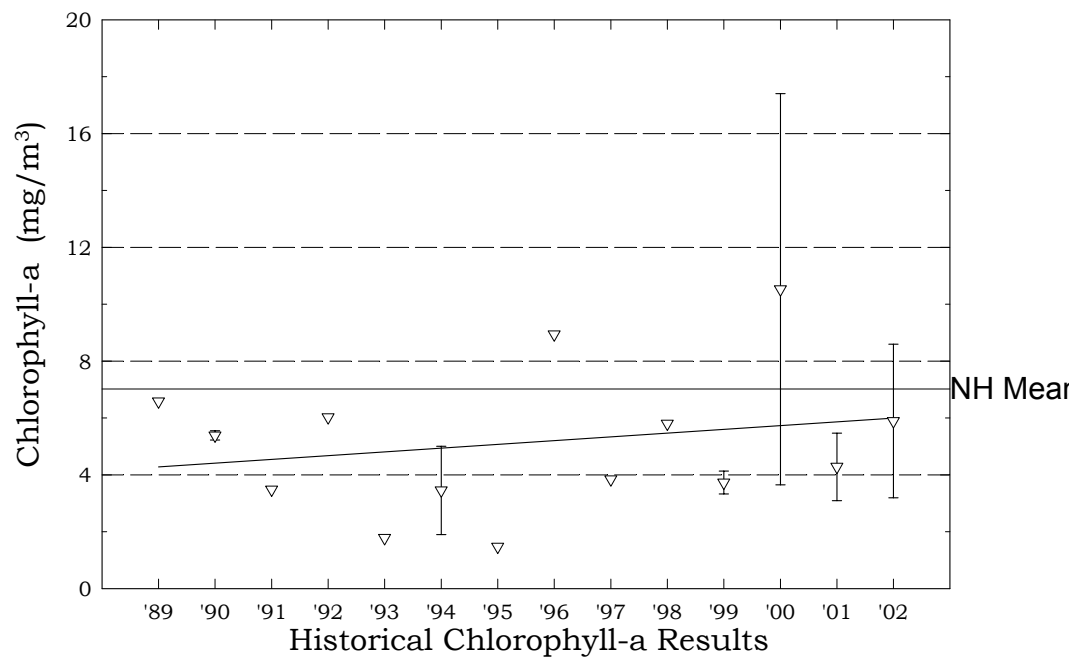
Figure 1. Monthly and Historical Chlorophyll-a Results

- **Figure 1 and Table 1:** The graphs in Figure 1 (Appendix A) show the historical and current year chlorophyll-a concentration in the water column. Table 1 (Appendix B) lists the maximum, minimum, and mean concentration for each sampling season that the lake/pond has been monitored through the program.

The historical data (the bottom graph) show that the 2002 chlorophyll-a mean is ***slightly less than*** the state mean. Overall, visual inspection of the historical data trend line (the bottom graph) shows ***a variable*** in-lake chlorophyll-a trend, meaning that the concentration has ***fluctuated*** since monitoring began in 1989.

For the 2003 Bi-Annual Report, since the lake/pond will have been sampled for at least 10 consecutive years, we will conduct a statistical

analysis of the data. This will allow us to objectively determine if there has been a significant change in the annual mean chlorophyll-a concentration since monitoring began.

While algae are naturally present in all lakes/ponds, an excessive or increasing amount of any type is not welcomed. In freshwater lakes/ponds, phosphorus is the nutrient that algae depend upon for growth. Therefore, algal concentrations may increase when there is an increase in nonpoint sources of nutrient loading from the watershed, or in-lake sources of phosphorus loading (such as phosphorus releases from the sediments). It is important to continually educate residents about how activities within the watershed can affect phosphorus loading and lake quality.

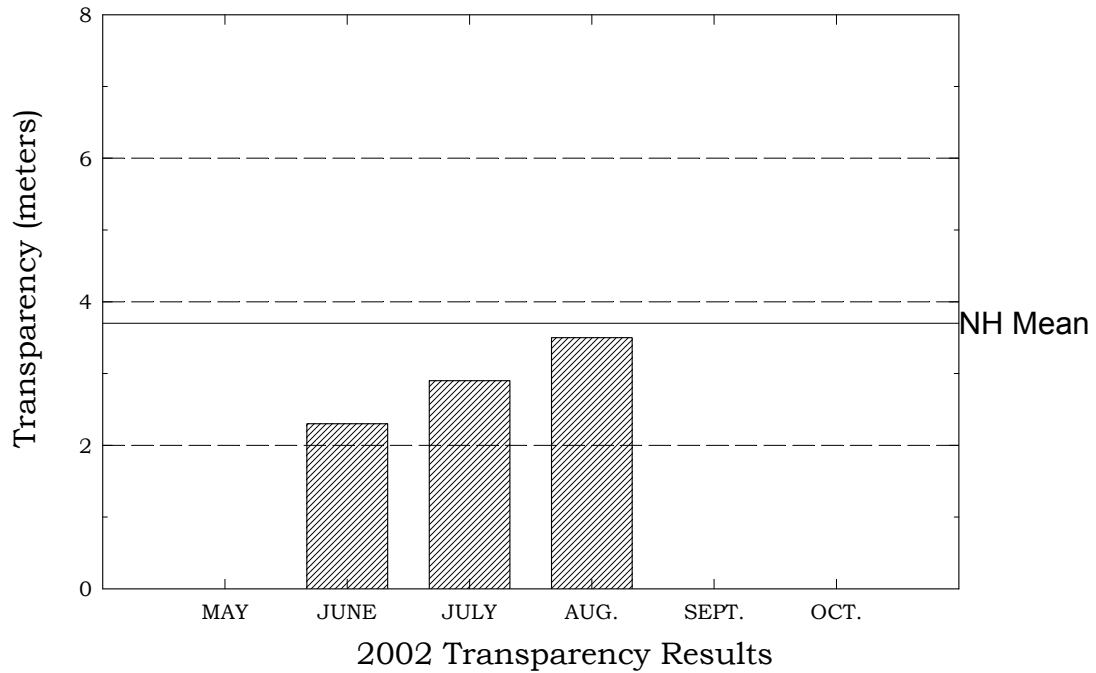
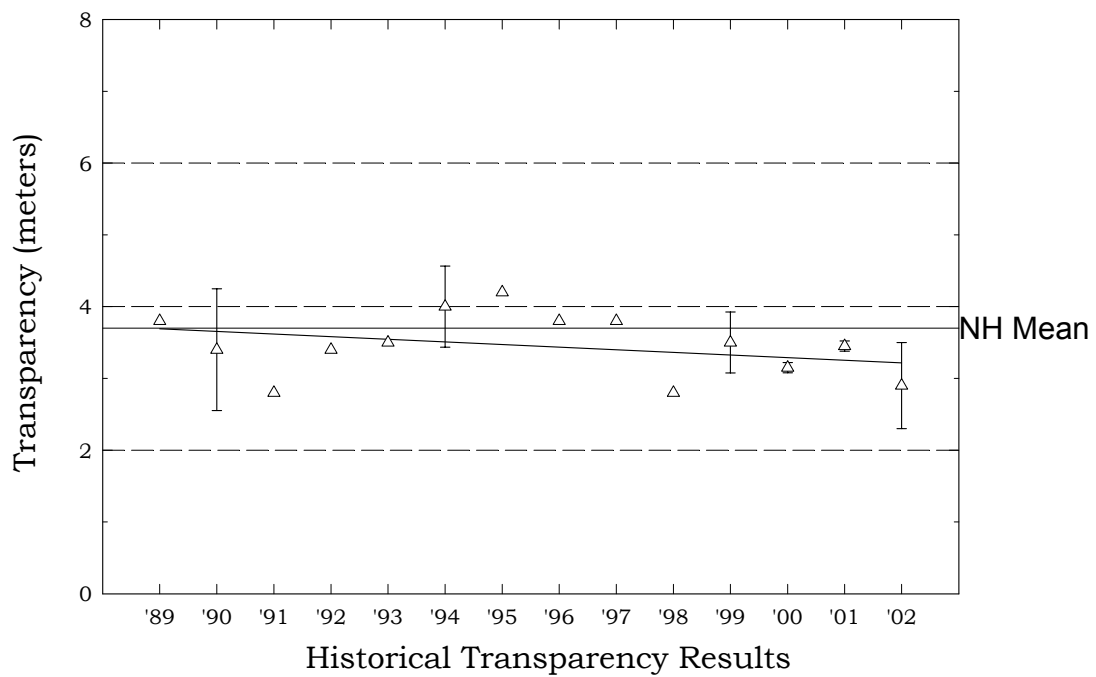
Figure 2. Monthly and Historical Transparency Results

- **Figure 2 and Table 3:** The graphs in Figure 2 (Appendix A) show historical and current year data for lake/pond transparency. Table 3 lists the maximum, minimum and mean transparency data for each sampling season that the lake/pond has been monitored through the program.

The historical data (the bottom graph) show that the 2002 mean transparency is **less than** the state mean.

It is interesting to note that as the chlorophyll-a concentration decreased from June to August this season, the transparency increased. We typically expect this inverse relationship in lakes. As the amount of algal cells in the water column decreases, the depth to which one can see into the water typically increases.

Overall, visual inspection of the historical data trend line (the bottom graph) shows **a slightly decreasing** trend for in-lake transparency, meaning that the transparency has **slightly worsened** since monitoring began.

Typically, high intensity rainfall causes erosion of sediments into the lake/pond and streams, thus decreasing clarity. Efforts should continually be made to stabilize stream banks, lake/pond shorelines, disturbed soils within the watershed, and especially dirt roads located immediately adjacent to the edge of tributaries and the lake/pond. Guides to Best Management Practices designed to reduce, and possibly even eliminate, nonpoint source pollutants are available from NHDES upon request.

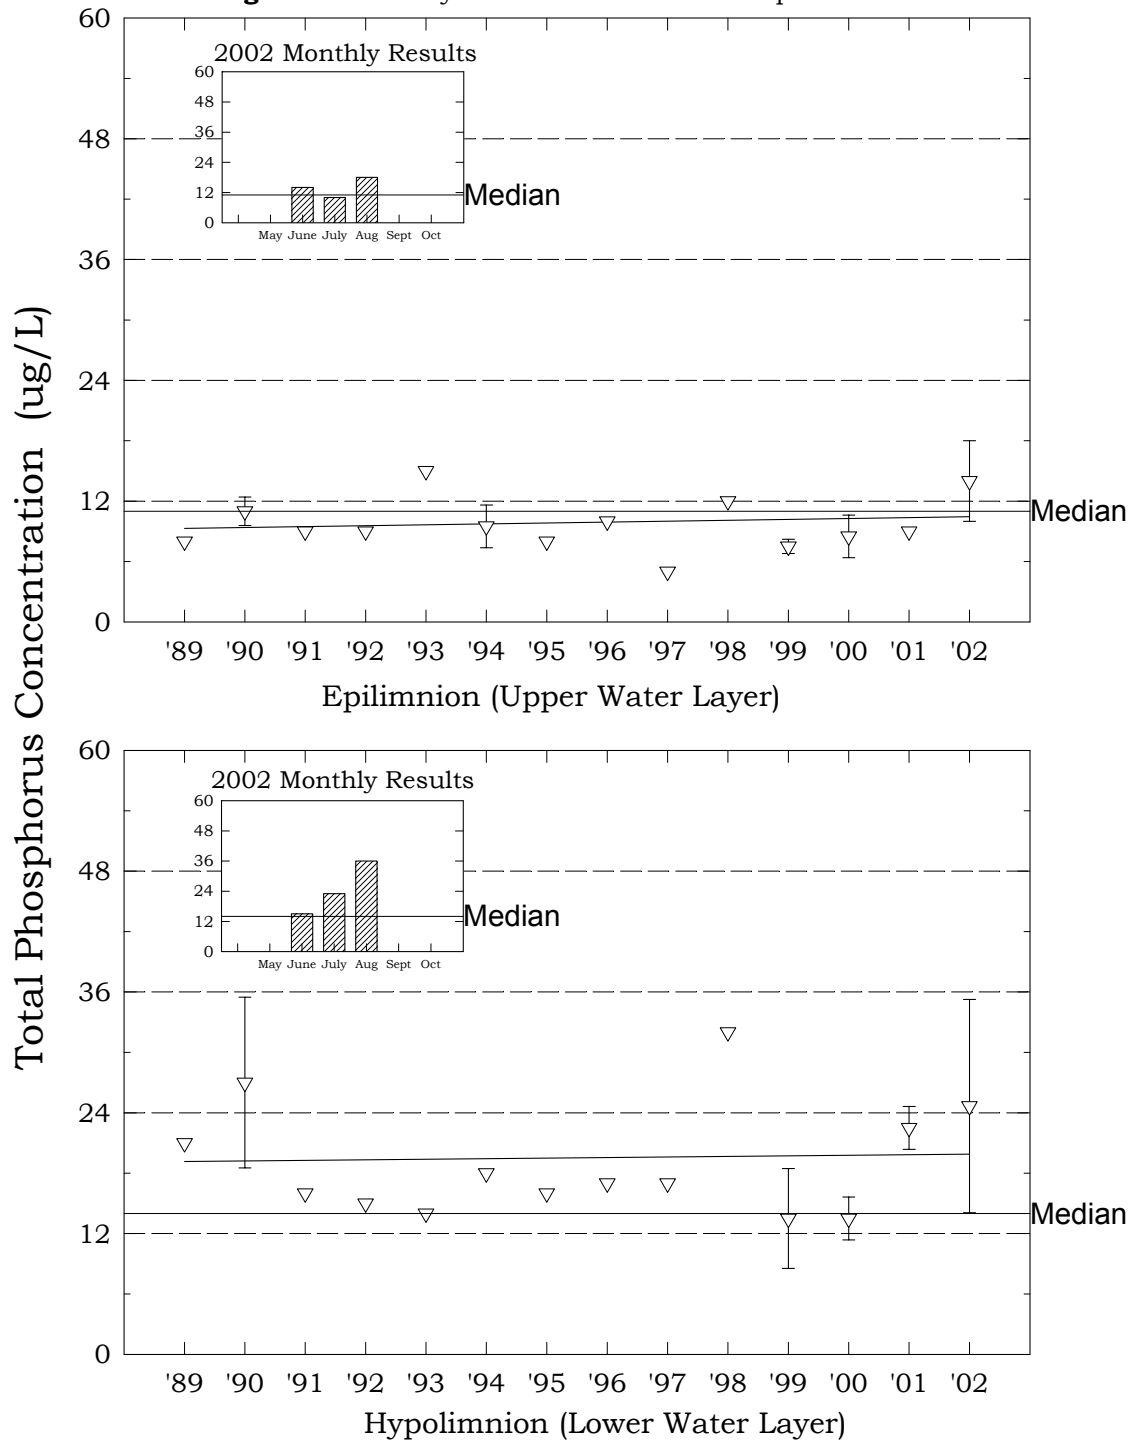
Figure 3. Monthly and Historical Total Phosphorus Data.

- **Figure 3 and Table 8:** The graphs in Figure 3 (Appendix A) show the amounts of phosphorus in the epilimnion (the upper layer) and the hypolimnion (the lower layer); the inset graphs show current year data. Table 8 (Appendix B) lists the annual maximum, minimum, and median concentration for each deep spot layer and each tributary since the lake/pond has joined the program.

The historical data for the epilimnion (upper layer) show that the 2002 total phosphorus mean is **slightly greater than** the state median. Overall, visual inspection of the historical data trend line for the epilimnion shows **a relatively stable** total phosphorus trend since monitoring began.

The historical data for the hypolimnion (lower layer) show that the 2002 total phosphorus mean is **greater than** the state median. Overall, visual inspection of the historical data trend line for the

hypolimnion shows **a variable** total phosphorus trend, which means that the concentration has **fluctuated** since monitoring began.

It is important to point out the phosphorus concentration in the hypolimnion **steadily increased** from June to August this season. This suggests that the process of **internal phosphorus loading** is occurring in the pond. Please refer to the discussion of Table 9 and 10 for a more detailed explanation.

One of the most important approaches to reducing phosphorus loading to a waterbody is to continually educate watershed residents about its sources and how excessive amounts can adversely impact the ecology and value of lakes and ponds. Phosphorus sources within a lake or pond's watershed typically include septic systems, animal waste, lawn fertilizer, road and construction erosion, and natural wetlands. If you would like to educate watershed residents about how they can help to reduce phosphorus loading into the lake/pond, please contact the VLAP Coordinator.
